NASA Electronic Parts and Packaging (NEPP) Program

NEPP Task: "Screening Techniques for Ceramic Capacitors with
Microcracks"

Susceptibility to Cracking of Different Lots of CDR35 Capacitors

Alexander Teverovsky

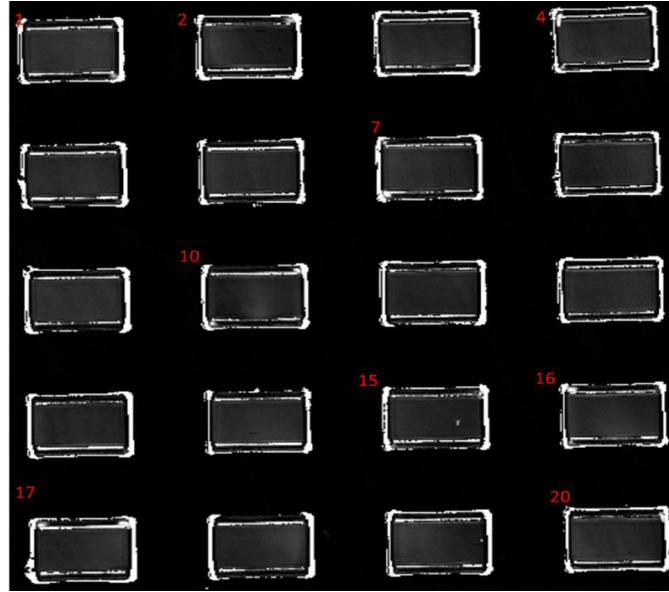
No anomalies in both lots of capacitors were observed during visual examinations using an optical microscope with magnification up to ten times. All capacitors from Mfr.C passed ultrasonic inspections, but some capacitors from Mfr.A had delaminations (see Fig.5.). Delaminations or possibly some internal cracks at the corners near terminations were detected in nine out of 20 tested capacitors (see details in report J17062 CSAM).

Figure 5. Results of bulk C-SAM scanning for 20 capacitors from Mfr.A (courtesy of Chris Greenwell, ASRC). Numbers correspond to the parts where delaminations were detected.

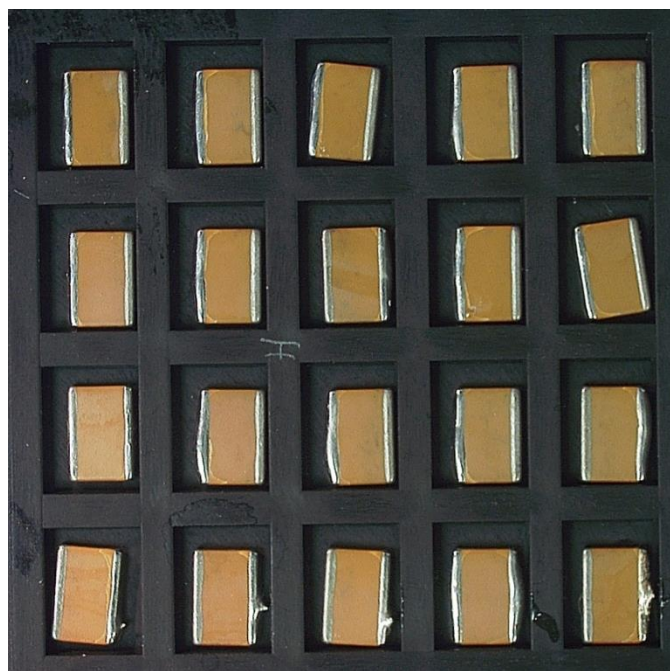
External visual examination of capacitors after terminal solder dip testing at 350 °C showed that capacitors from Mfr.C had only one sample with a tiny corner crack; however, all 20 tested capacitors from Mfr.A had significant corner cracking and in many cases the cracks were stretching along the whole terminal (see Fig.10). C-SAM inspections confirmed the presence of corner cracks and delaminations in capacitors from Mfr.A and did not reveal any anomalies in capacitors from Mfr.C (see Fig. 11).

Figure 10. Capacitors from Mfr.A after terminal solder dip testing.

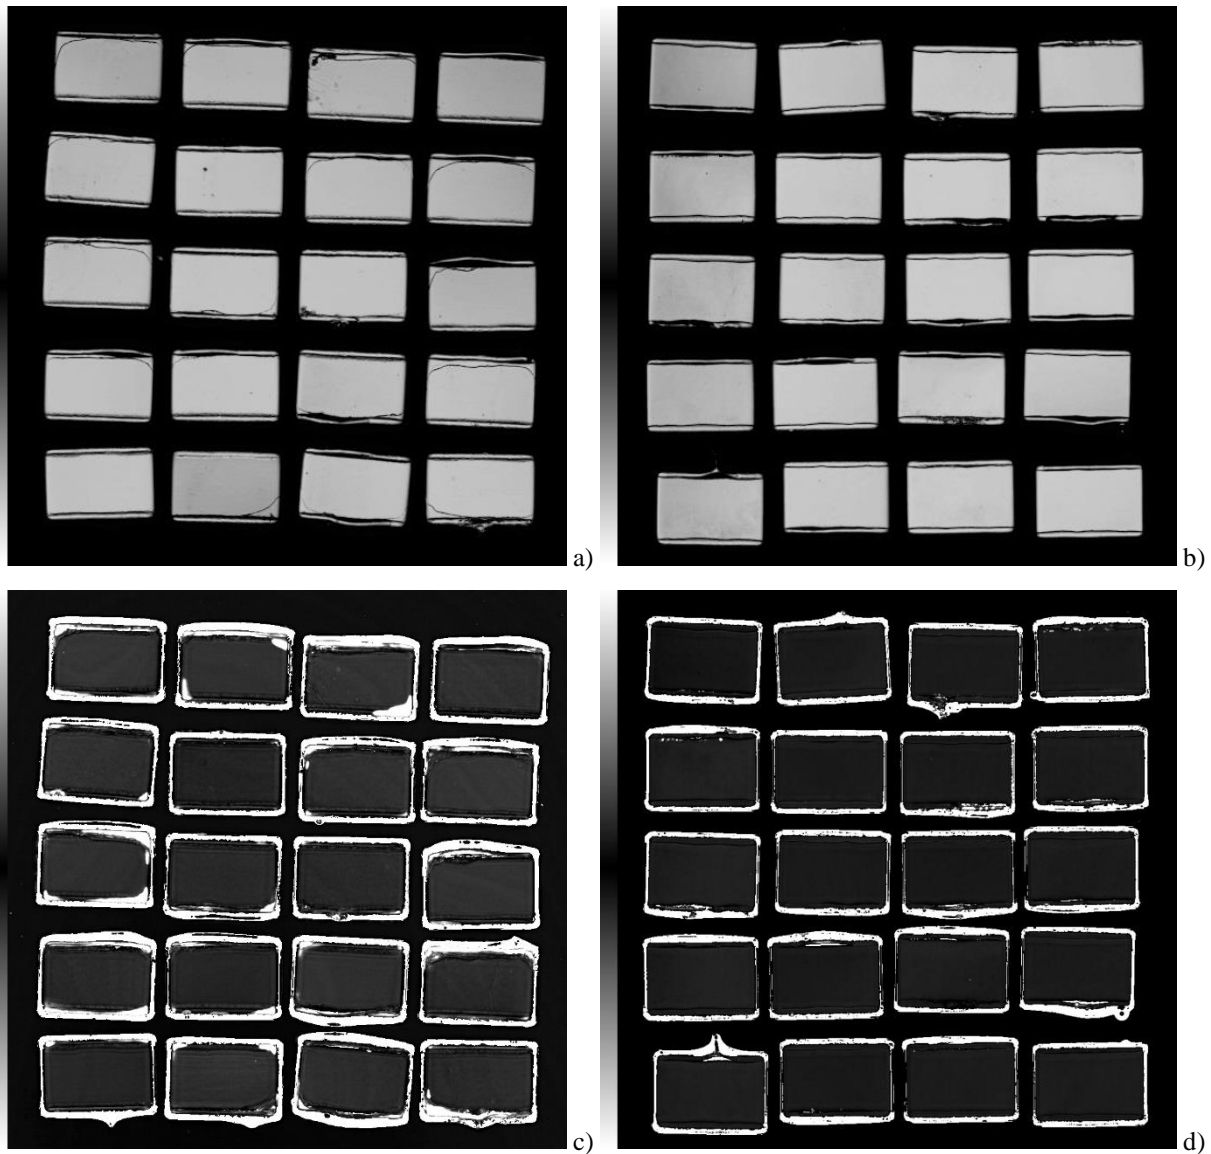
Figure 11. Surface (a, b) and bulk (c, d) scan acoustic images of capacitors from Mfr.A (a, c) and Mfr.C (b, d)) after TSD350.

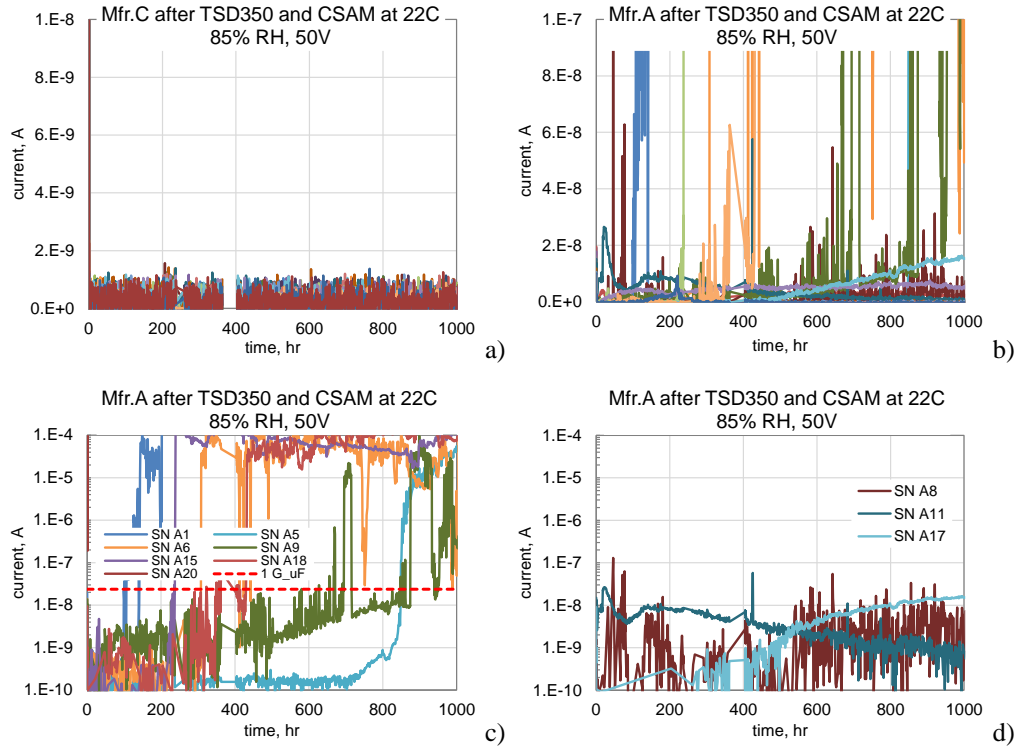
Finally, the test voltage was increased to the rated level, and leakage currents at 22 °C and 85% RH were monitored for 1000 hours more. Results of this testing are shown in Fig.14. All samples from Mfr.C remained below 1 nA, whereas 6 out of 20 samples from Mfr.A had leakage currents exceeding the formal criteria based on the requirements for $IR \geq 1 \text{ Gohm}_\mu\text{F}$ that corresponds to 23.8 nA at 50 V. The failures were observed after different periods of testing ranging from 100 to 860 hours (Fig. 14c); however, the failures were intermittent and the parts exhibited unstable currents even before the failures occurred. Three parts that did not formally fail the testing behaved also erratically (Fig.14d). A similar behavior of different lots of 0.47 μF 50 V capacitors was observed in our previous work [6], and is common for ceramic capacitors with cracks.

Figure 14. Leakage currents in CDR35 0.47 μ F 50 V capacitors from Mfr.C (a) and Mfr.A (b, c, d) during 1000 hour testing at 22 $^{\circ}$ C, 85% RH, and 50 V. Leakage currents in figures c) and d) have logarithmic scale to reveal details of the behavior of capacitors that failed (c) and had some spiking of currents that remained below the failure criteria (d).

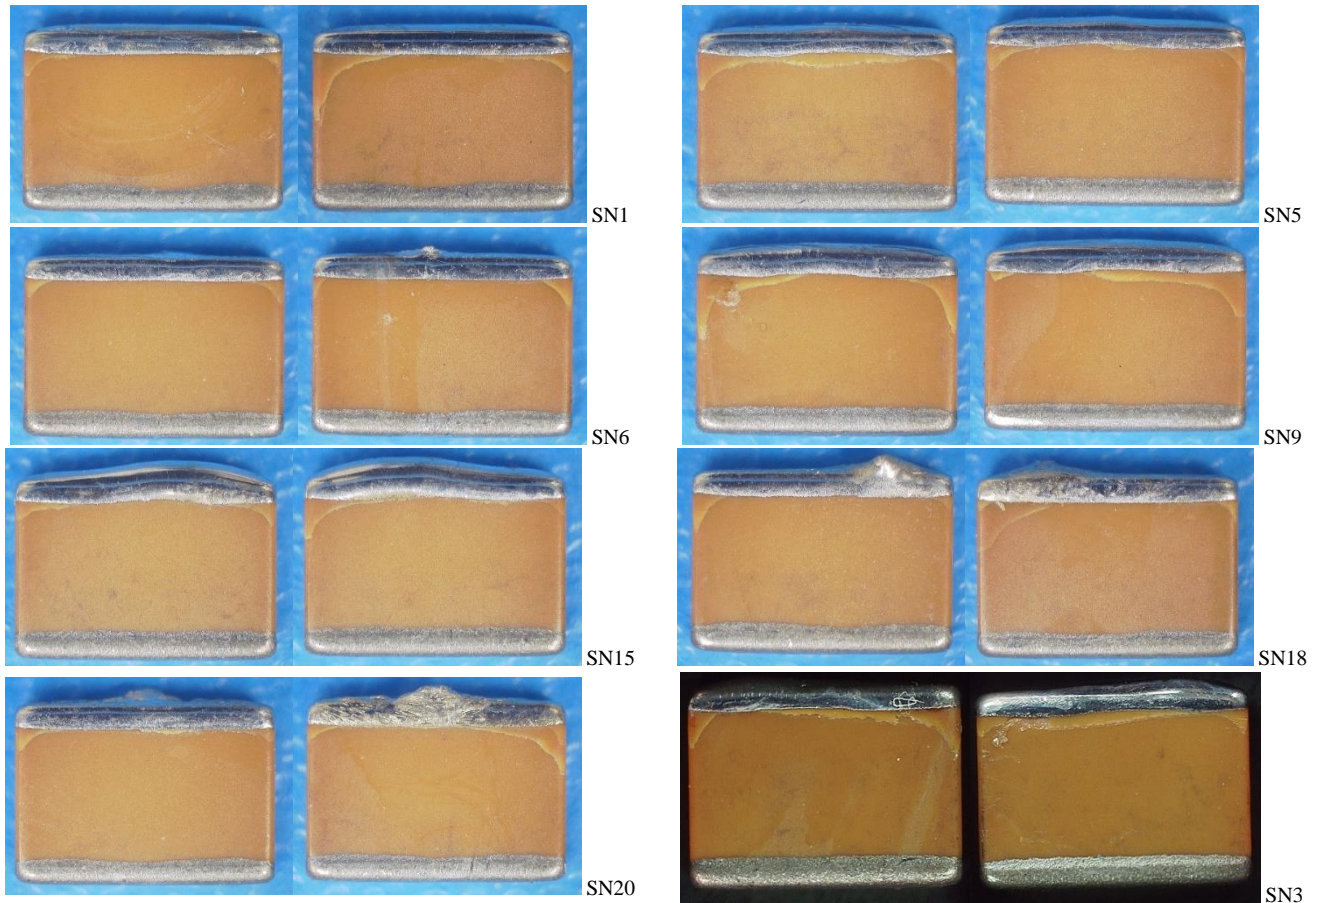
Optical images showing cracks at the solder dipped terminal in all failed samples are shown in Fig. 16. Note, that other samples, e.g. SN3, had similar cracks, but did not fail electrically. This means that the presence of corner cracks and delaminations does not necessarily result in electrical failures.

Figure 16. Two-side external views of the failed samples (blue background) and a sample with normal electrical characteristics, SN3.

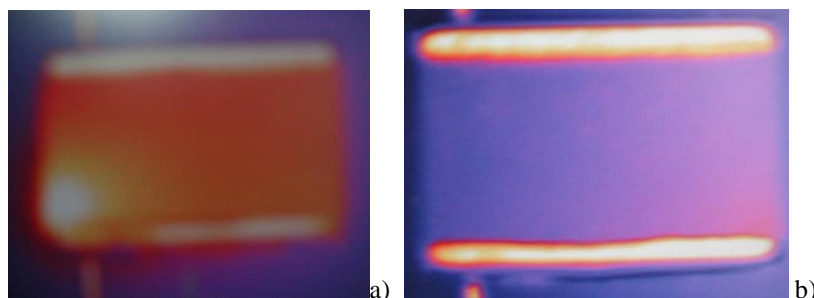
Due to low leakage currents, attempts to reveal hot spots in the parts using an infrared camera were not successful for any samples except for SN1 and SN5. The hot spots were clearly observed in SN1 and could be detected in SN5 (see Fig.18). In both cases, the shorting areas were at the corners of capacitors where the cracking was most significant.

Figure 18. Infrared images of SN1 (a) and SN5 (b) indicating hot spots at the corners of capacitors.

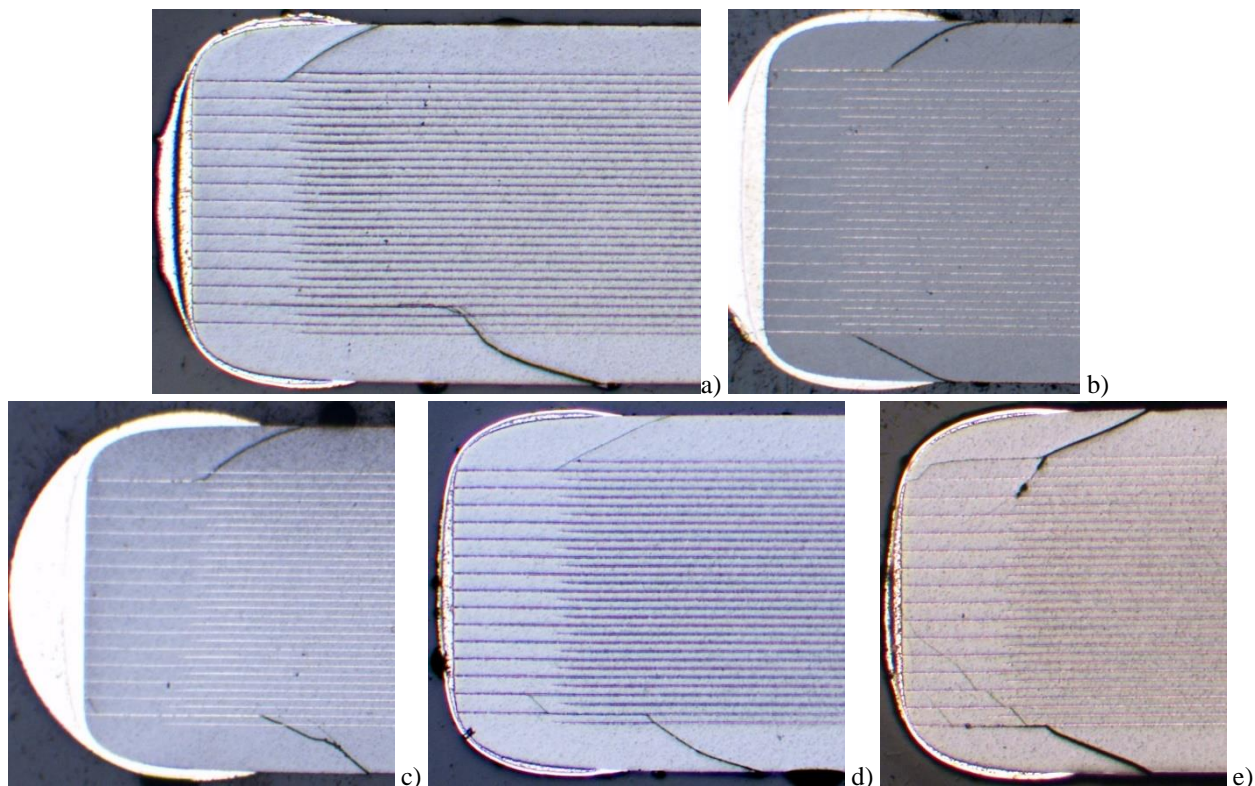
Overall views of cracks that were revealed near corners of the capacitors during cross-sectioning are shown in Fig.19. Typical close-up and SEM views of the cracks are shown in Fig.20 to 24. In all cases the cracks that apparently initiated at the surface of capacitors near terminals were directed through the cover plates towards the central area of terminals at an angle $\sim 45^\circ$. The cracks stopped at electrodes and propagated further along the electrode/ceramic interfaces. A similar appearance of the crack and delamination was observed during failure analysis of the part failed on the engineering BEI Encoder unit (report J16090FA). However, in that case, the crack was internal and originated likely from the delamination.

No conductive materials were revealed by SEM and EDS examinations. Still, most likely they were present somewhere inside the cracks as a result of electrochemical migration (ECM) that was accelerated by the presence of moisture and resulted in formations of a conductive path between the electrodes.

Figure 19. Overall views of crack revealed during cross-sectioning. a) SN1 $R \sim 18k$, b) SN5 $R \sim 100k$, c) SN15 $R \sim 10G$, d) SN18 $R \sim 20M$, e) SN20 $R \sim 1M$. The values of R were measured after each cross-sectioning step with a hand meter at ~ 0.7 V.

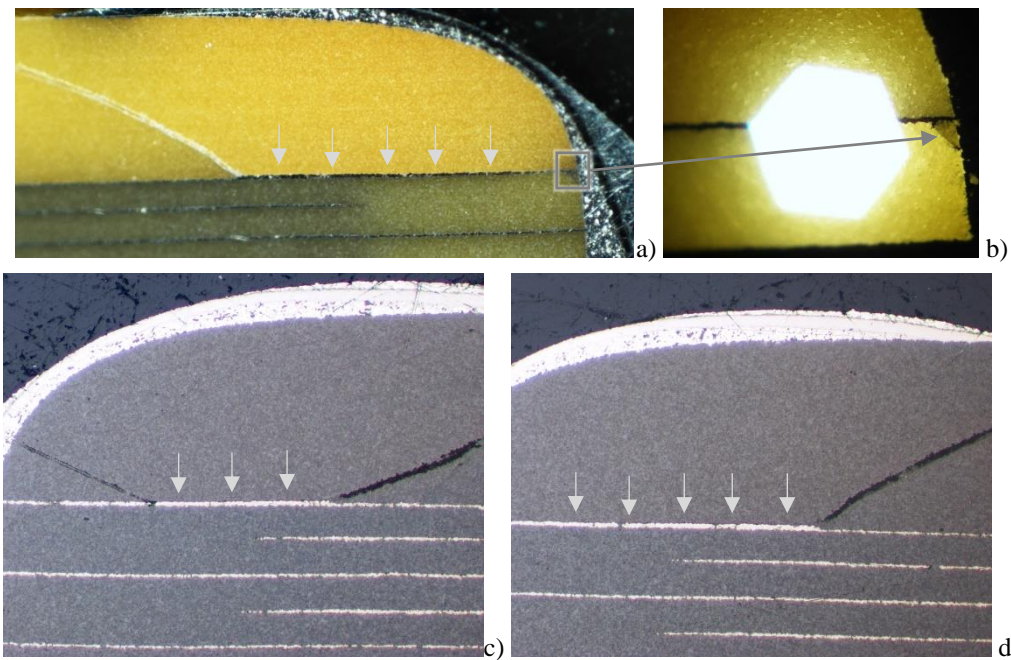
Figure 21 Close-up of the top (a, b) and bottom (c, d) areas of SN5 (Fig. 19b). A tiny crack between delamination and terminal (b) was revealed using the vicinal illumination technique. Apparently increased thickness of metallization after the crack crossing metal electrode (c, d) is likely due to delamination and smearing of the metal electrode.

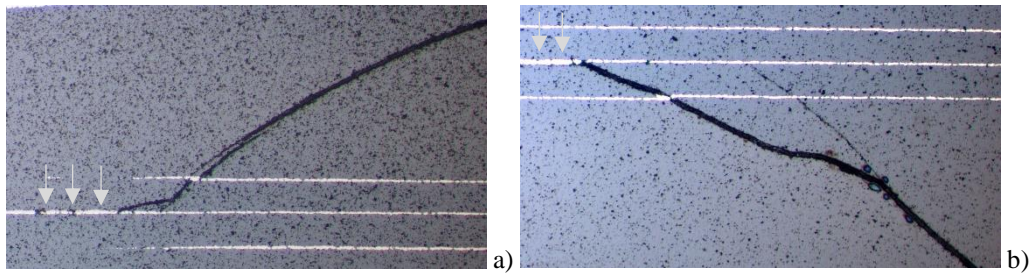
Figure 22. Cracks at the top (a) and bottom (b) corners in SN15 (Fig. 19c).

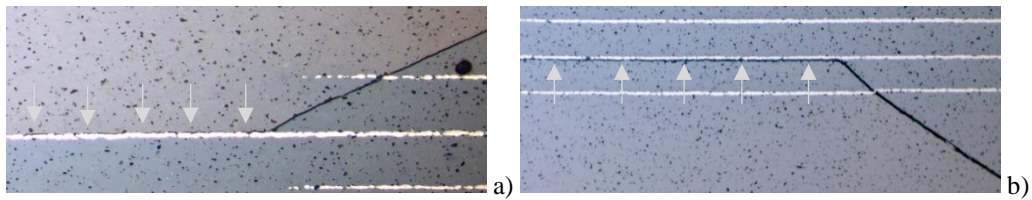
Figure 23. Cracks at the top (a) and bottom (b) corners and delaminations in SN18 (Fig. 19d).

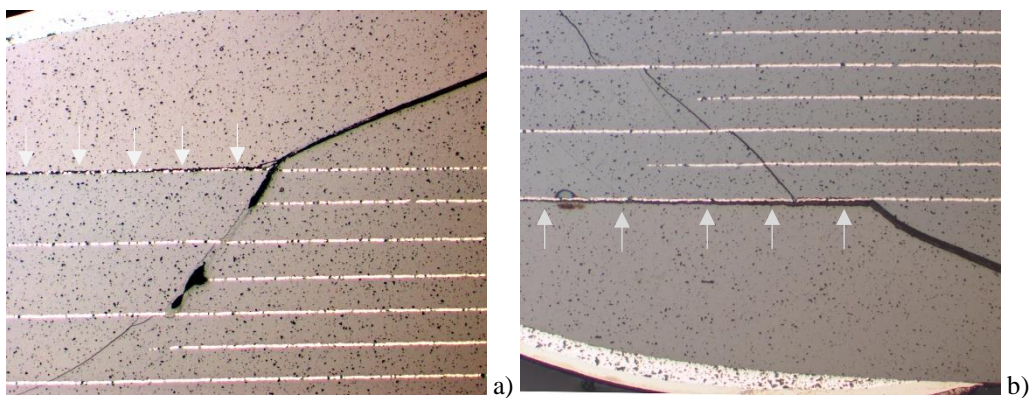
Figure 24. Cracks at the top (a) and bottom (b) corners and delaminations in SN20 (Fig. 19e).

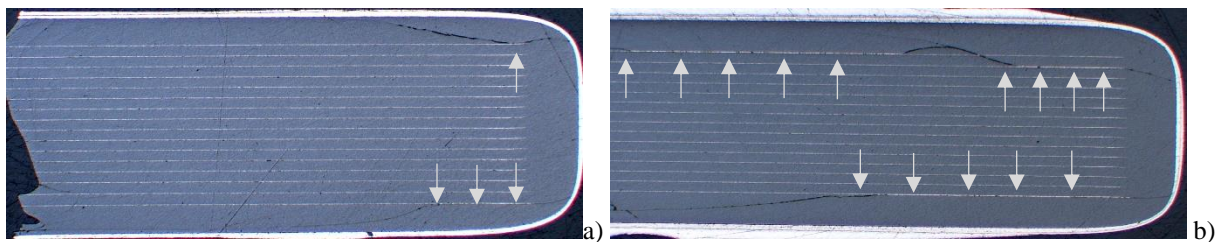
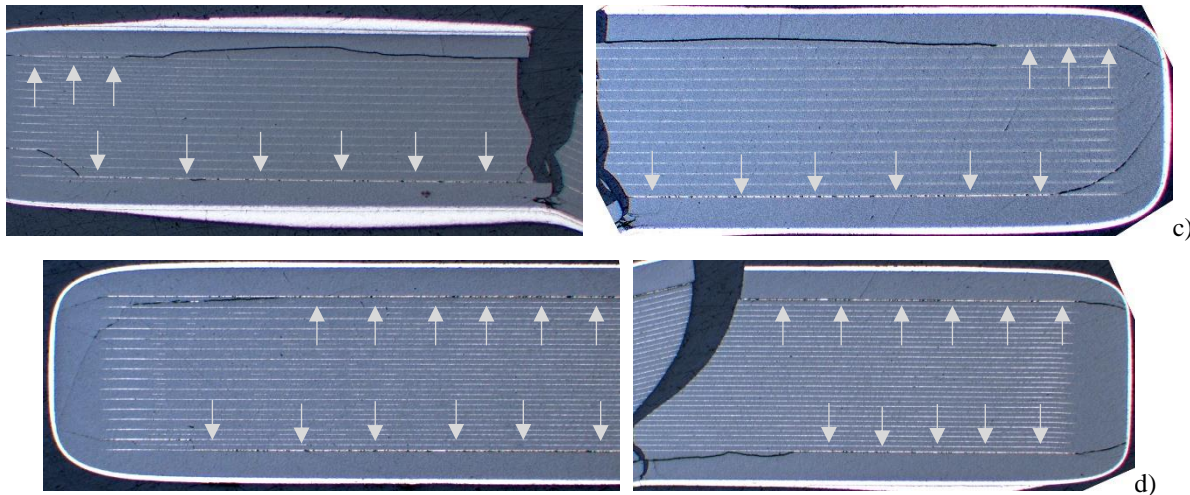
No delaminations were observed on virgin samples from Mfr.A and on both, virgin and post-TSD350 groups of samples from Mfr.C. Results of cross-sectioning for the post-TSD350 Mfr.A capacitors (see Fig.25) revealed delaminations along the electrodes similar to what was observed in failed samples. It appears that cracks initiated by fracturing propagated through the part along the electrode/ceramic delaminated interfaces close to the surface of capacitors.

Figure 25. Cross-sections along the terminals that were stressed by TSD350 for SN1c (a), SN2c (b), right and left portions of SN4c (c) and SN5c (d). The parts did not fail electrically during humidity testing, but were fractured in the middle before cross-sectioning.
